Estero Infrared Thermography Inc.
 100 Estero Blvd., Ft. Myers, FL, 12345
 Tel: (941) 123-4567 Fax: (941) 123-4568

Project: Swing Arm Plant

Customer: Jarvis Manufacturing

Date: Feb 23, 2022 Scale: N.T.S.

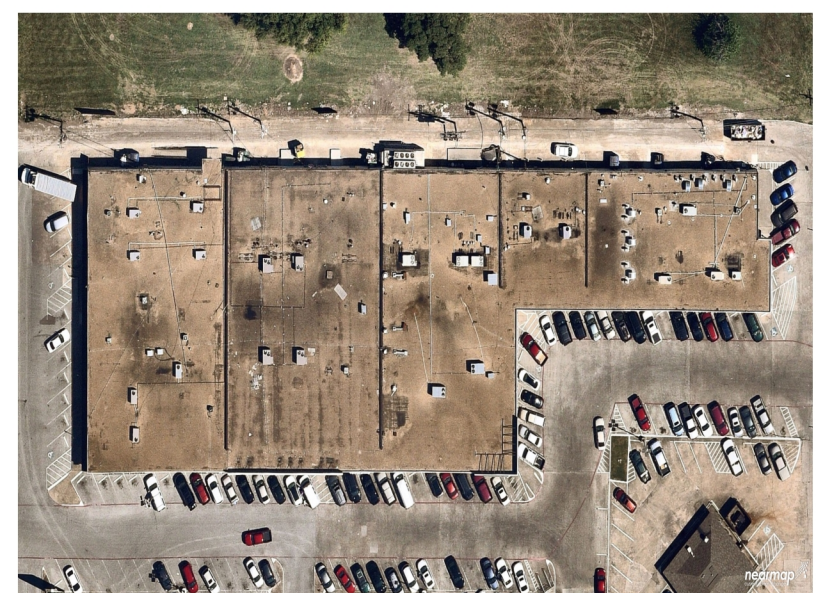
Existing 4 ply built up roof over 2" perlite insulation and concrete deck. 3969sqft of wet insulation will need to be removed and infilled prior to recover. Strongly suggest the addition of insulation crickets along the low wall to direct water to existing scuppers.
