# Estero Roofing

## Repair Report

Number: 1009

**Facility:** Hurricane Bay Facility  
708 Fishermans Wharf,  
Ft. Myers, FL 33931  
**Contact:** Sam Fisher - (239) 854-6244

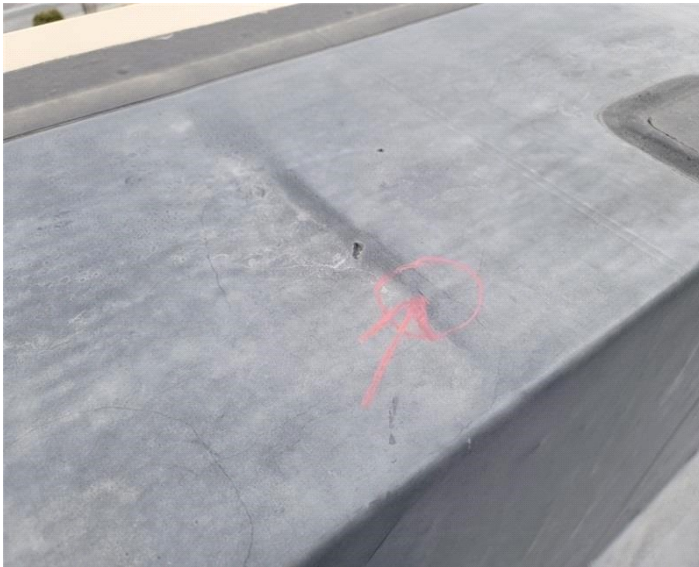
F-102 Field Membrane - puncture/Hole/tear # 1

All holes in the membrane are considered high severity due to their high leak potential.

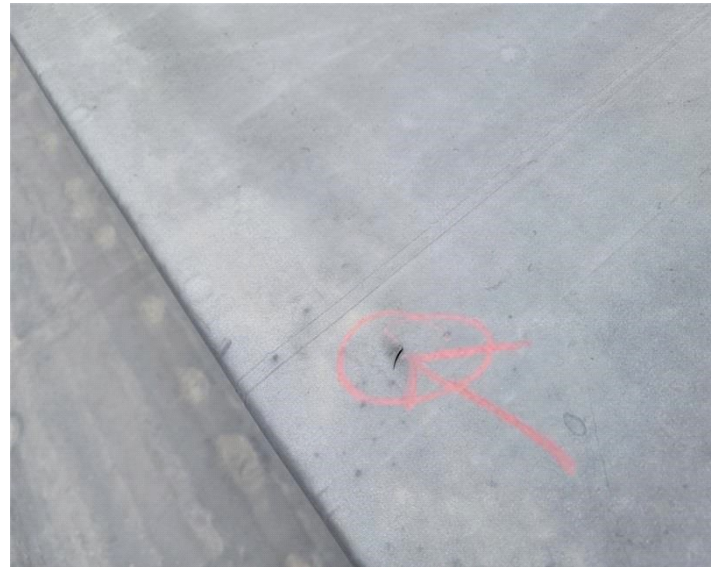
F-102 Field Membrane - puncture/Hole/tear # 2

All holes in the membrane are considered high severity due to their high leak potential.

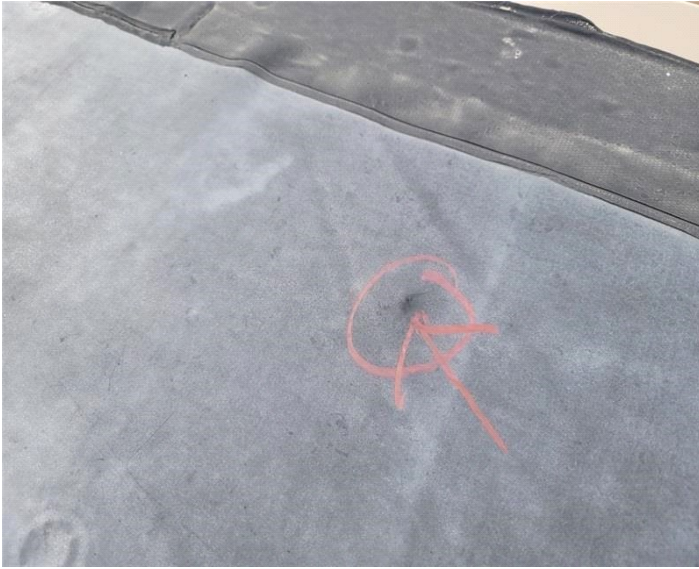
F-102 Field Membrane - puncture/Hole/tear # 3

All holes in the membrane are considered high severity due to their high leak potential.
