Inspection Report

Facility: Hurricane Bay Facility

Customer: Dixie Fish Company

Inspection Date: Wednesday, March 16, 2022

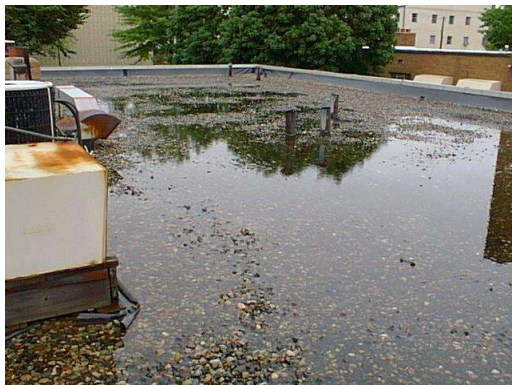
Condition: Ponding
Severity: 1 - Low
Qty: SF: 3 LF: 12 EA: 3

Ponding includes standing water or evidence of standing water by the presence of staining or accumulation of debris. Water that remains longer than 48 hours is considered ponded water. Ponding adds weight to the roof, and can cause many undesirable problems. If the roof membrane is damaged in a ponded area, the water may drain into the roof system and building.
