Inspection Report

Facility: Hurricane Bay Facility

Customer: Dixie Fish Company

Roof Condition Summary

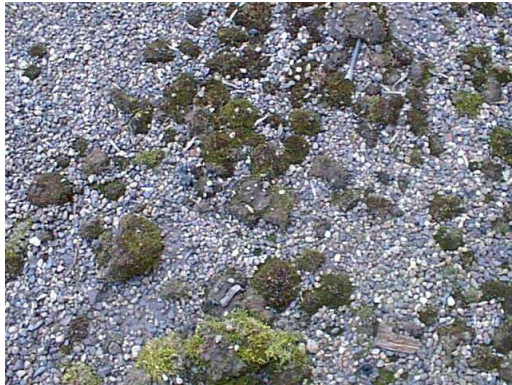
Condition: Vegetation- in membrane
Severity: 3 - High
Qty: SF: 2 LF: 8 EA: 2

Vegetation has penetrated the membrane.

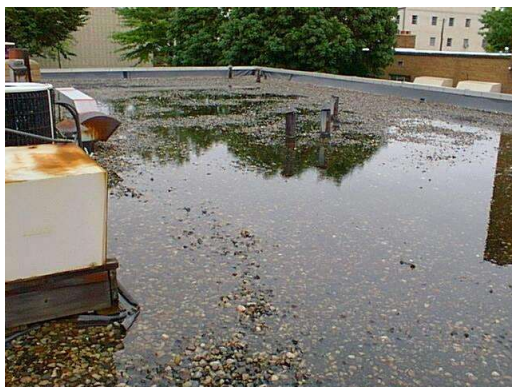
Condition: Ponding
Severity: 1 - Low
Qty: SF: 3 LF: 12 EA: 3

Ponding includes standing water or evidence of standing water by the presence of staining or accumulation of debris. Water that remains longer than 48 hours is considered ponded water. Ponding adds weight to the roof, and can cause many undesirable problems. If the roof membrane is damaged in a ponded area, the water may drain into the roof system and building.
