Inspection Report

Facility: Hurricane Bay Facility

Customer: Dixie Fish Company

Inspection Date: Wednesday, March 16, 2022

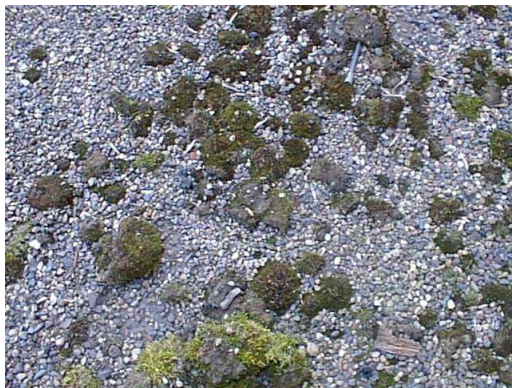
Condition: Vegetation- in membrane
Severity: 3 - High
Qty: SF: 2 LF: 8 EA: 2

Vegetation has penetrated the membrane.
