Estero Infrared Thermography Inc.
 100 Estero Blvd., Ft. Myers, FL, 12345
 Tel: (941) 123-4567 Fax: (941) 123-4568

Project: Swing Arm Plant

Customer: Jarvis Manufacturing

Date: Feb 23, 2022 Scale: N.T.S.

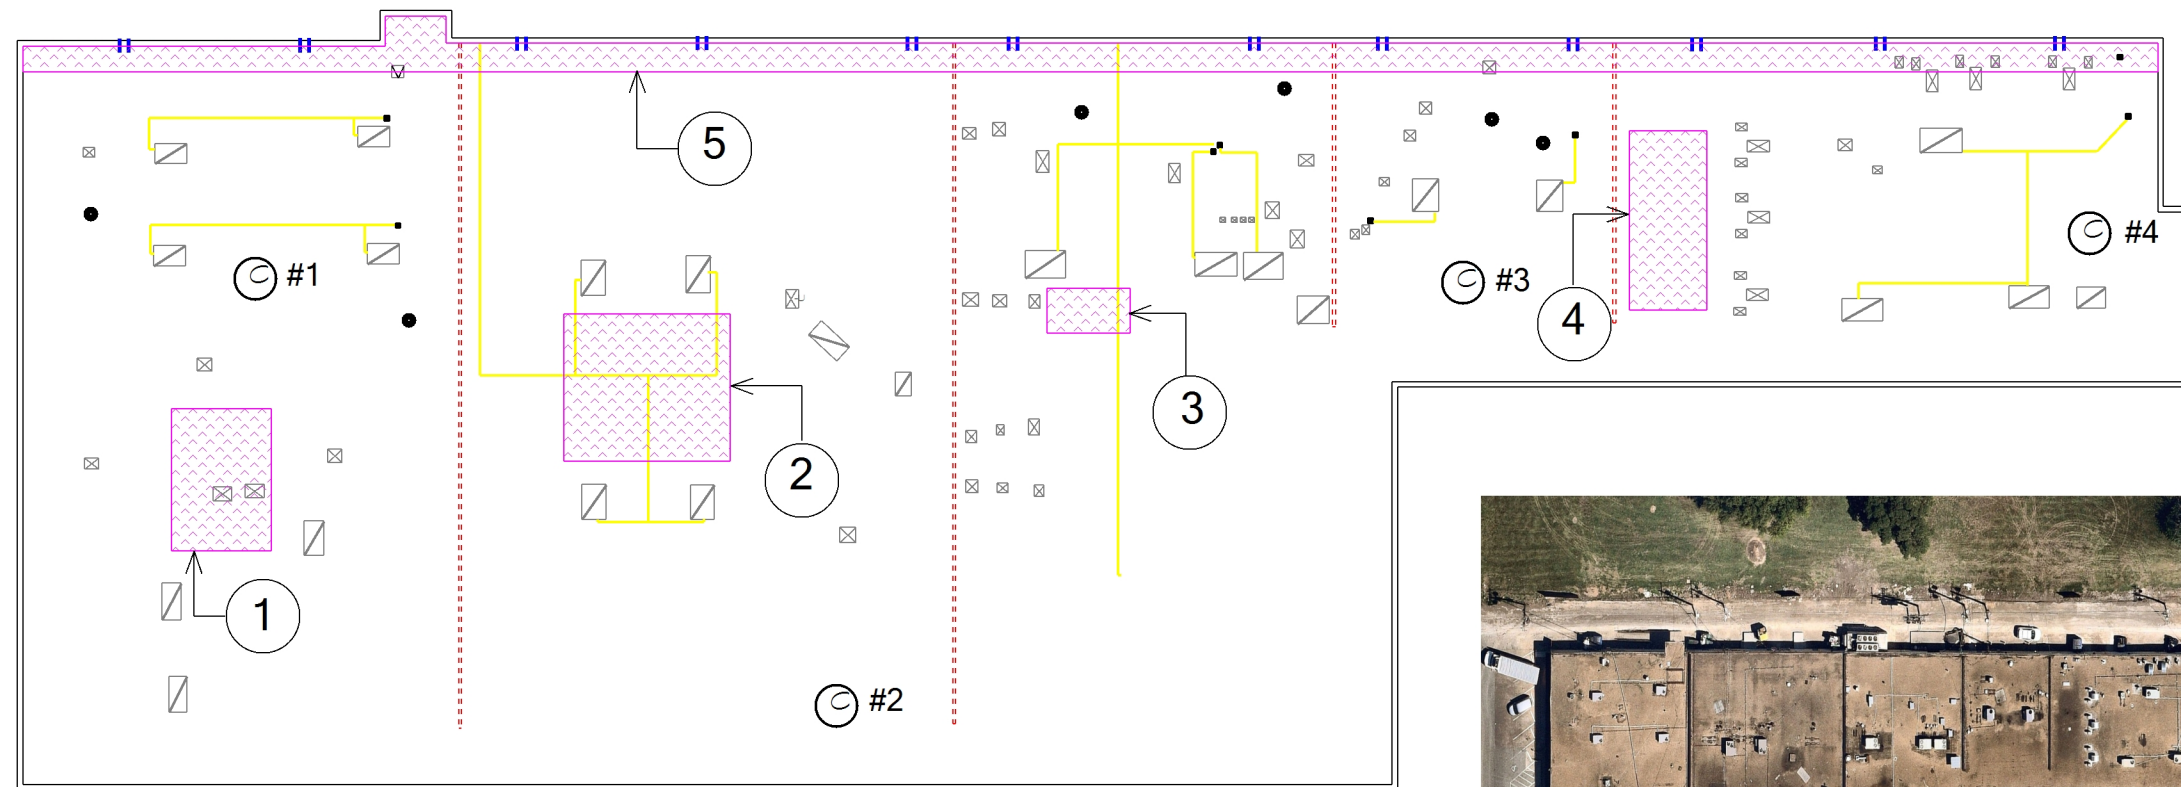
Core #1
 4 ply Built Up
 2" Perlite Insulation
 Concrete deck

Core #2
 4 ply Built Up
 2" Perlite Insulation
 Concrete deck

Core #3
 4 ply Built Up
 2" Perlite Insulation
 Concrete deck

Core #4
 4 ply Built Up
 2" Perlite Insulation
 Concrete deck

Existing 4 ply built up roof over 2" perlite insulation and concrete deck. 3969sqft of wet insulation will need to be removed and infilled prior to recover. Strongly suggest the addition of insulation crickets along the low wall to direct water to existing scuppers.
