Inspection Report

Facility: Hurricane Bay Facility

Customer: Dixie Fish Company

Roof Condition Summary

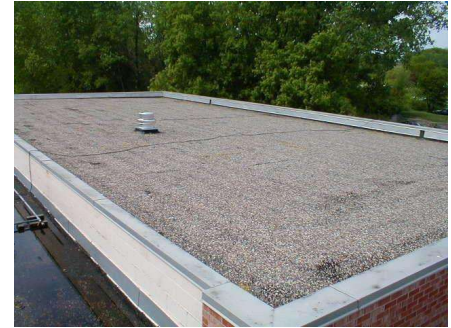
Roof: Roof A

Condition Assessment: 25 - Critical

This roof is in critical condition. Roofs in critical condition are in need of immediate attention. Water damage is imminent without the recommended repairs or replacement.
