Inspection Report

Facility: Hurricane Bay Facility

Customer: Dixie Fish Company

Inspection Date: Wednesday, March 16, 2022

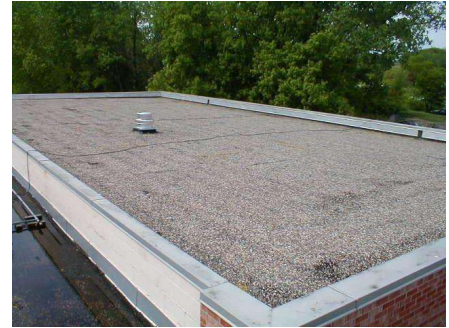
Roof: Roof A

Roof System: 4 Ply Asphalt & Gravel
Install Date: 2012 - Estimated
Roof Deck: Galvanized Metal
Roof SF: 10,000
Elevation: 22
Interior Sensitivity: 2 - Medium
Warranty: Carlisle

Condition Assessment: 25 - Critical

This roof is in critical condition. Roofs in critical condition are in need of immediate attention. Water damage is imminent without the recommended repairs or replacement.
