# Photo Proposal

**Facility:** Hurricane Bay Facility  
**Address:** 708 Fishermans Wharf,  
Ft. Myers, FL 33931

**Customer:** Dixie Fish Company  
**Address:** 714 Fisherman's Wharf,  
Ft. Myers Beach, FL 33931

Work Order #: 35887

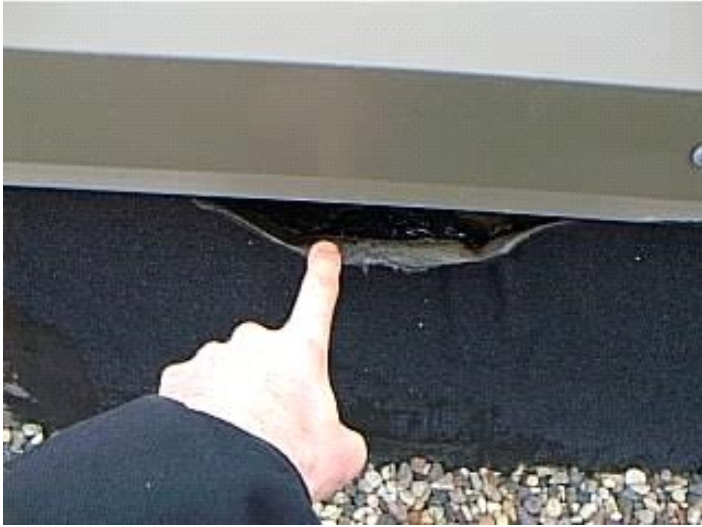
BF-110 Base Flashing - open lap # 1  
Seam in flashing is open through entire width, allowing water to penetrate the flashing.

**#1 BF-106 Base Flashing- delaminated**

Remove delaminated base flashing, install new base flashing in set in cold adhesive, tie into existing roofing system  
150 lineal feet - \$ 1,875.00

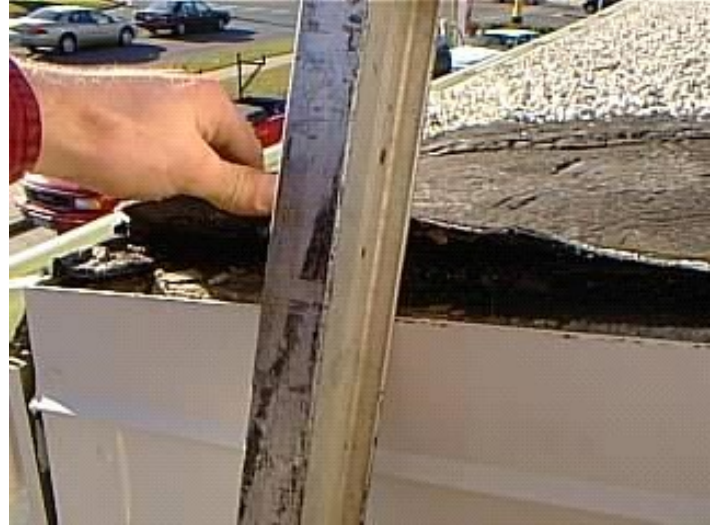
ME-100 Metal Edge - deteriorated membrane # 2  
The flashing membrane is deteriorated and should be replaced to avoid further degradation.

**#2 ME-100 Metal Edge- deteriorated membrane**

Cut back deteriorated membrane, install new base sheet mechanically fastened to deck followed by a granulated cap sheet set in cold adhesive, tied into existing roof system.  
200 Square feet - \$2,400.00

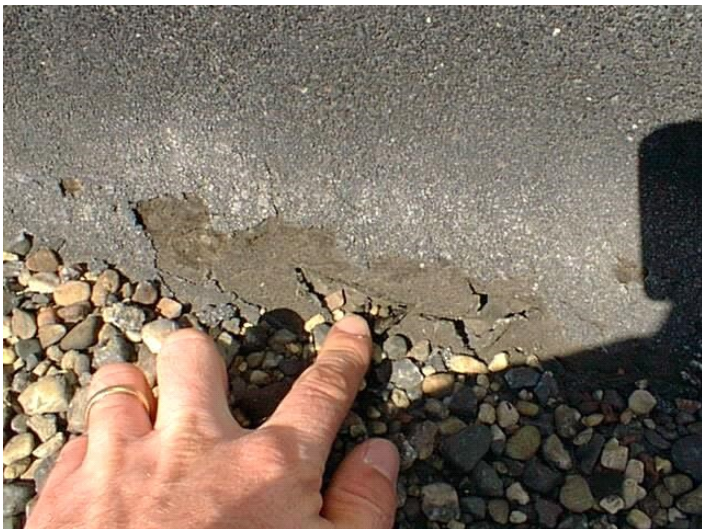
F-102 Field Membrane - puncture/Hole/tear # 3  
All holes in the membrane are considered high severity due to their high leak potential.

**#3 BF-102 Base Flashing- puncture/Hole/tear**

Remove deteriorated base flashing, install new base flashing in set in cold adhesive, tie into existing roofing system  
2 lineal feet - \$175.00

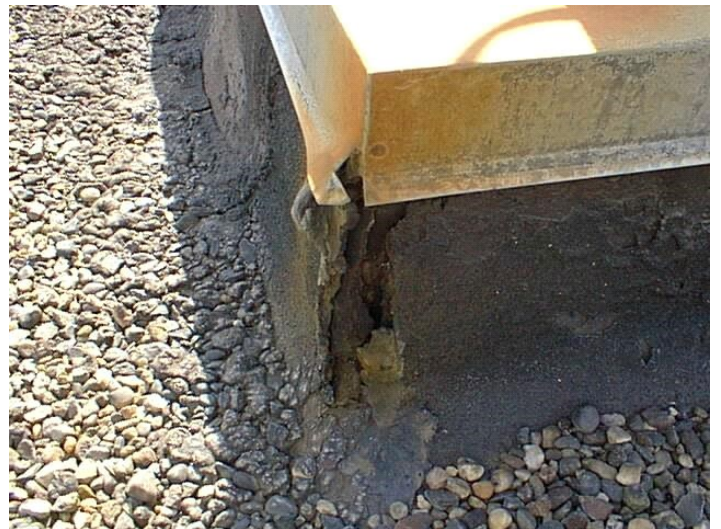
P-100 Penetration - deteriorated membrane # 4  
The flashing membrane is deteriorated and should be replaced to avoid further degradation.

**#4 BF-102 Base Flashing- puncture/Hole/tear**

Remove deteriorated base flashing, install new base flashing in set in cold adhesive, tie into existing roofing system  
4 lineal feet - \$225.00
